James City County Shoreline Management Plan

*Prepared for
James City County and
Virginia Coastal Zone Management Program*

Shoreline Studies Program

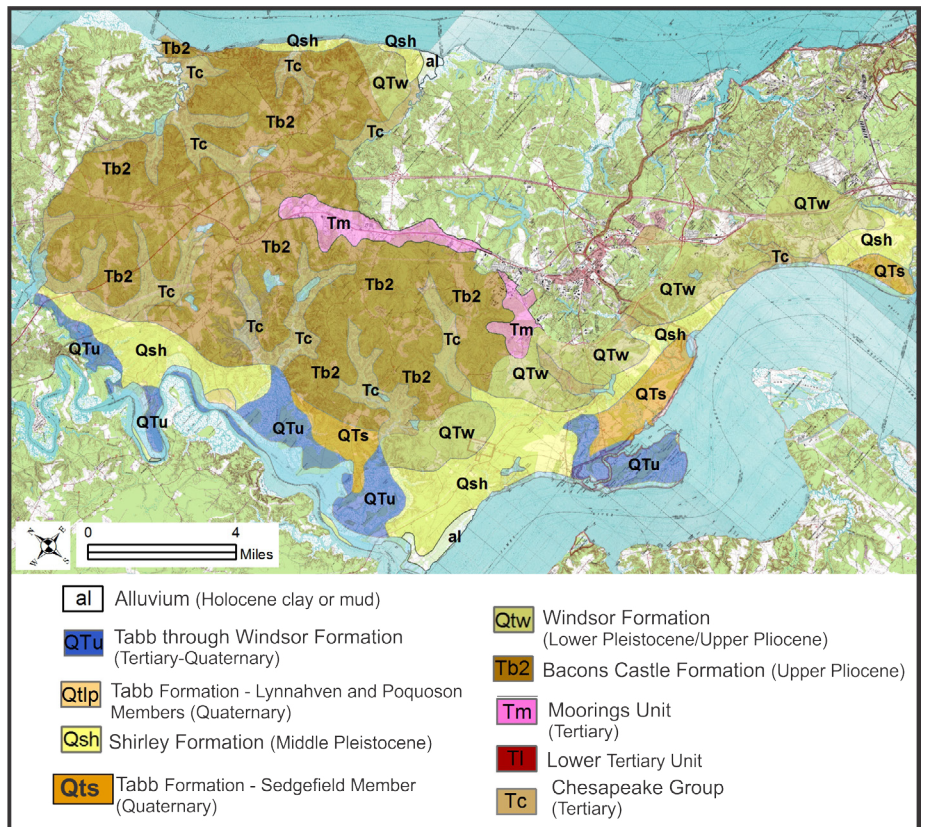
Figure 2-1. Geology of James City County (Mixon et al., 1989).

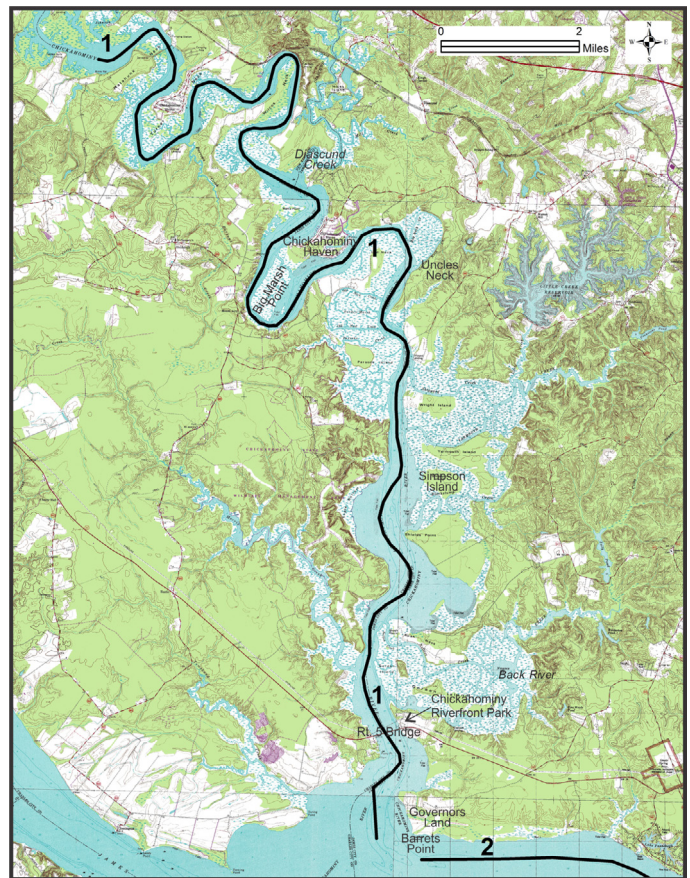
Figure 2-2. Topographic sheet of the Chickahominy River James City County. Also shown are the reach designations.

The coastal morphology, topography, and hydrology of James City County are seen in Figures 2-2, 2-3, and 2-4. Along the James River, the Chickahominy River marks the transition zone between the sharp meandering tidal channels of the upriver James River and the wider estuarine section of the watershed. There is a similar but smaller scale transition up the Chickahominy River at about Simpson Island (Figure 2-2). Here, as on the James River, the erosion processes go from tide dominated in the upriver section to

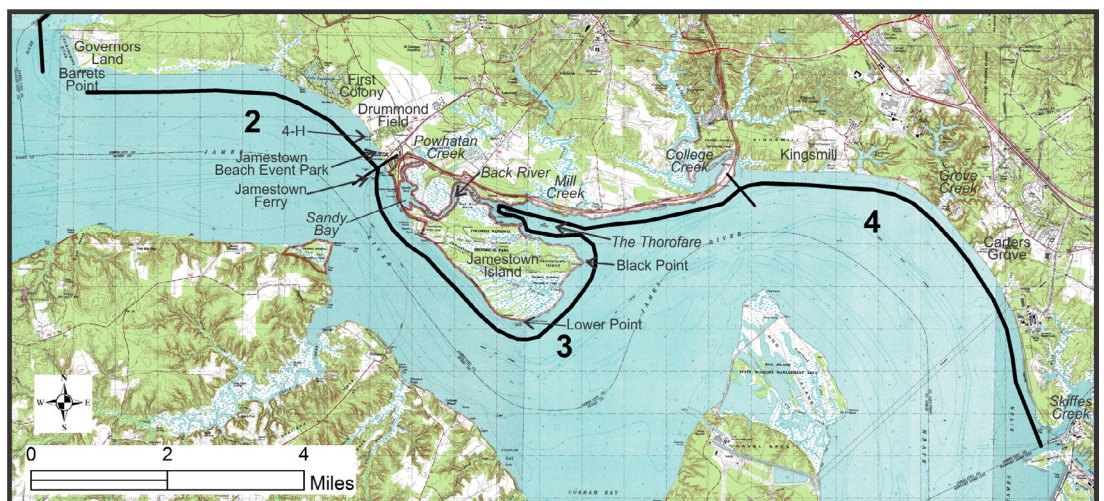
Figure 2-3. Topographic sheet of the James River section of James City County. Also shown are the reach designations.

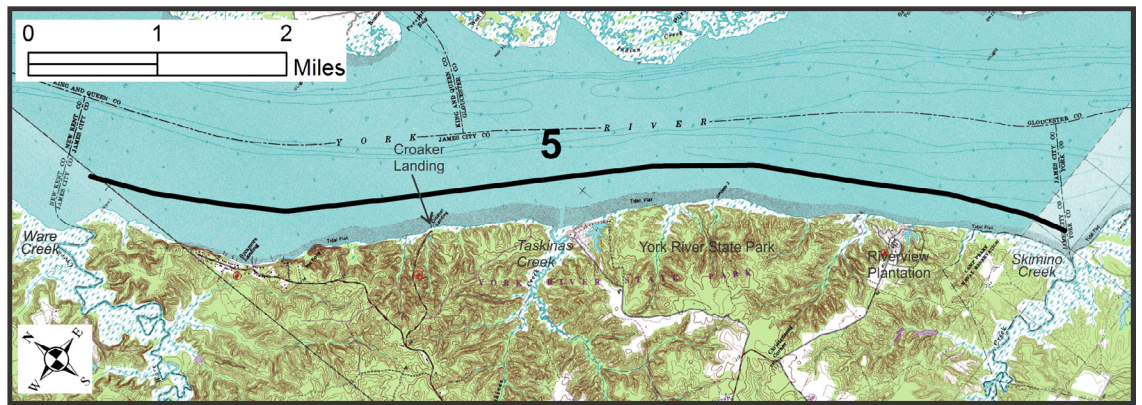
Figure 2-4. Topographic sheet of the York River section of James City County. Also shown are the reach designations.

Reach 5 lies along the York River side of James City County beginning at the mouth of Skimino Creek and extending upriver to Ware Creek (Figure 2-4). The reach begins as a broad tidal marsh with an erosive peat bank along the shore. The marsh extends up the York River for about one mile narrows and transitions to a low developed upland bank. The first low lot has a narrow eroding fringe that is protected by a low sill (Figure 2-17). The Riverview Plantation Drive shore extends about 4,000 feet and is an interfluve between two unnamed small tidal creeks. Most of the lots have remaining marsh fringe with an eroding peat scarp with some rock sills and revetments.

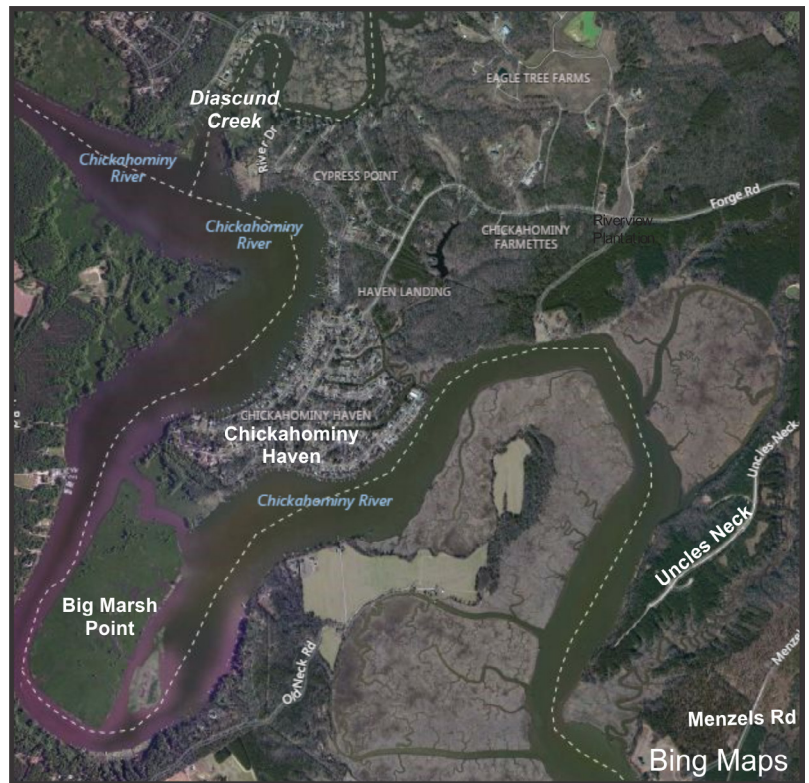
Figure 2-5. Reach 1 Bing map of the most upriver section of the Chickahominy in James City County.

The 1.5 miles south of the New Kent County line of Reach 1 are developed with many single homes, cottages, and numerous piers and docks (Figure 2-5). One development, Chickahominy Haven, spans the whole neck and includes several hundred feet of canal shoreline that was likely created in the 1960s. Much of the shoreline has been hardened with various types of bulkheads. The meandering coast becomes a fresh water marsh around Big Marsh Point which has become an island due to a channel cut just south of Chickahominy Haven.

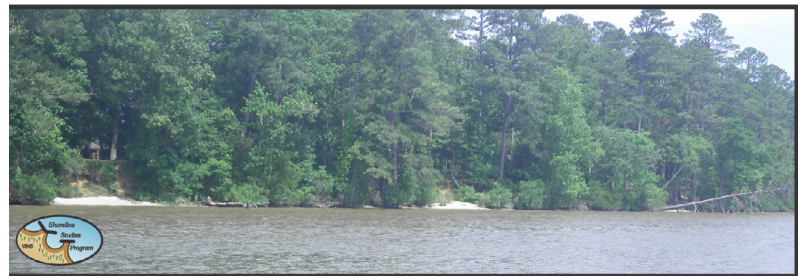
Figure 2-6. Reach 1 undeveloped, low eroding banks on the Chickahominy River.

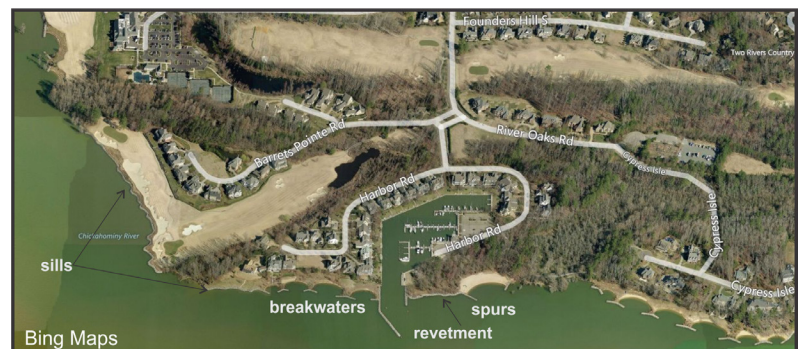
Figure 2-7. Reach 1 and 2 Bing map of Governors Land development at Barrets Point.

The Governors Land development at Barrets Point occurs at the confluence of the Chickahominy and James Rivers (Reaches 1 and 2). The Governors Land coast was protected with a series of a combination of revetments, sills, spurs and breakwater systems, today what are called living shorelines (Figure 2-7). Many of these structures were installed as the high-end homes and golf course were under construction in the 1990s. Governors Land extends along the coast about 2.5 miles along the James River, Reach 2, but much of it is bordered by undeveloped swamp forest coast (Figure 2-8).

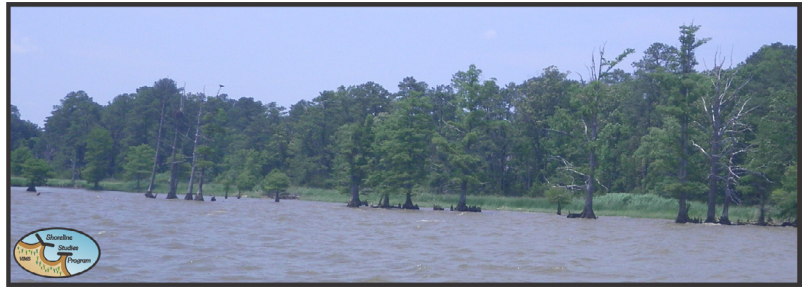
Figure 2-8. Reach 2 undeveloped swamp land along the James River.

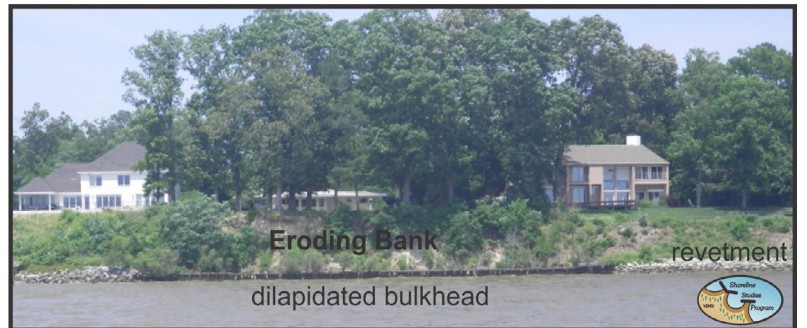
Figure 2-9. Reach 2 First Colony eroding bank behind a dilapidated bulkhead.

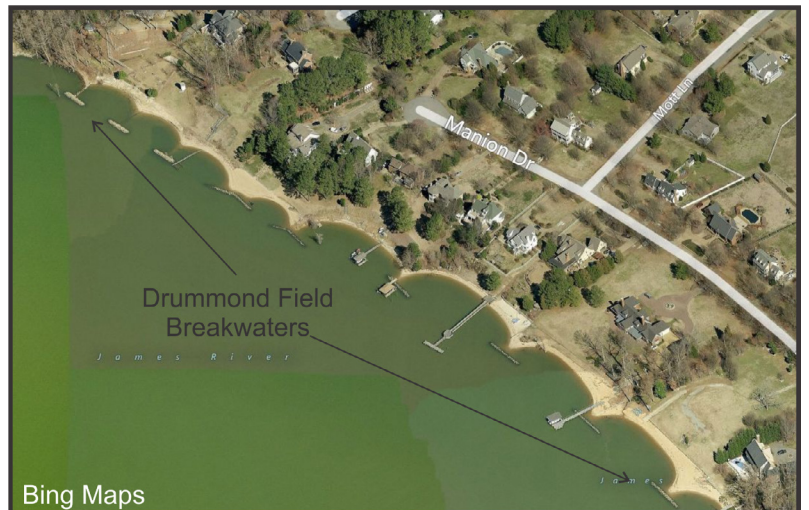
Figure 2-10. Reach 2 Drummond Field breakwaters that have been providing shore erosion control since 1985.

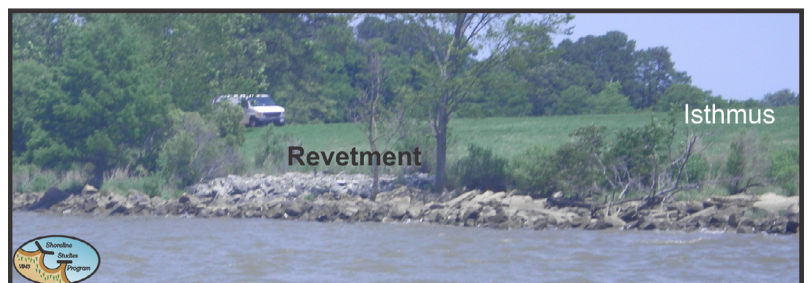
Figure 2-11. Reach 2 small revetment that protects the isthmus that connects Jamestown Island to the mainland.

Between Jamestown Settlement and the entrance to Sandy Bay, a small segment of beach extends downriver to a low revetment that protects the isthmus that connects Jamestown Island to the mainland (Figure 2-11). A short bridge over Sandy Bay connects the mainland to Jamestown Island. In early 1900s, the Jamestown site was protected by a sloped concrete block revetment which has needed repairs over the years but has provided shore protection to the site of high archeological significance. The concrete block revetment transitions to a more recently installed rock revetment that extends downriver about 1,500 feet and ties into another older revetment for another 1,500 feet. From that point, downriver to Lower Point, around Jamestown Island to Black Point and The Thorofare, a series of headland breakwaters and spurs were strategically placed in front of eroding archeological sites of national significance. The design of the structures were based on the 1999 shoreline management plan conceptual designs (Hardaway *et al.*, 1999).

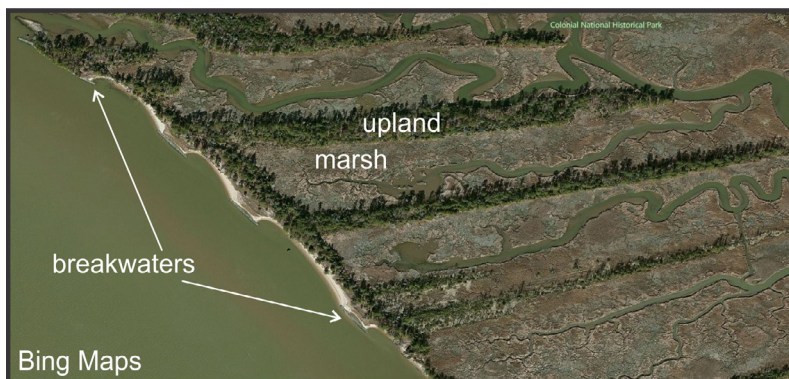
Figure 2-12. Reach 2 Bing map showing the breakwaters that were built along Jamestown Island's James River shore.

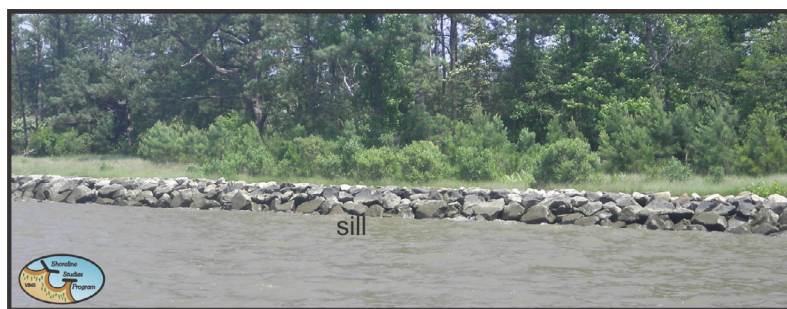
Figure 2-13. Reach 3 marsh sill along the The Thorofare.

control structures were placed along the shoreline to allow the adjacent shoreline to erode toward equilibrium. These structures were installed in 2003/2004. Black Point, a significant Native American site, was protected by a gapped sill and other headland breakwaters were strategically placed along the north shore of the Thorofare. Along The Thorofare and Back River, three separate sills were placed along archeological rich uplands for shore protection (Figure 2-13).

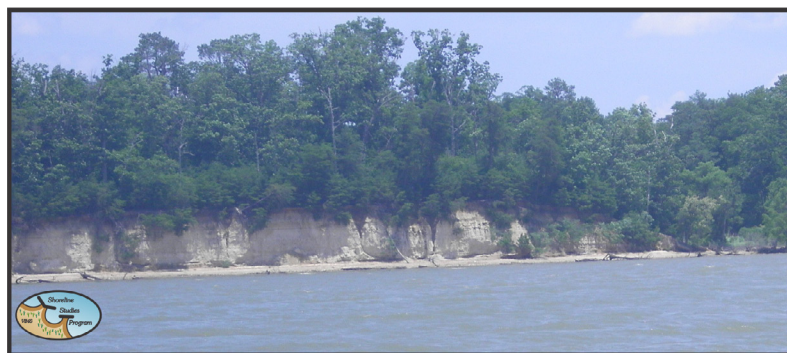
Figure 2-14. Reach 4 eroding high banks along the James River.

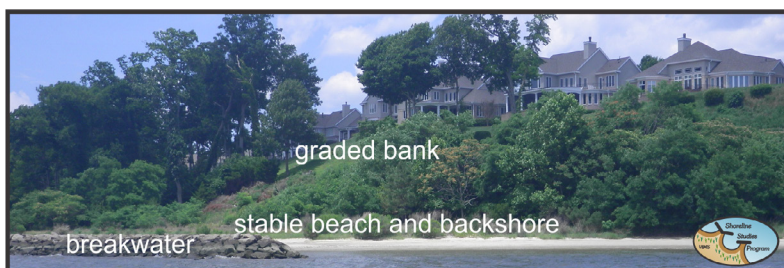
Figure 2-15. Reach 4 breakwater, graded bank, and stable beach and backshore along the Kingsmill shoreline on the James River.

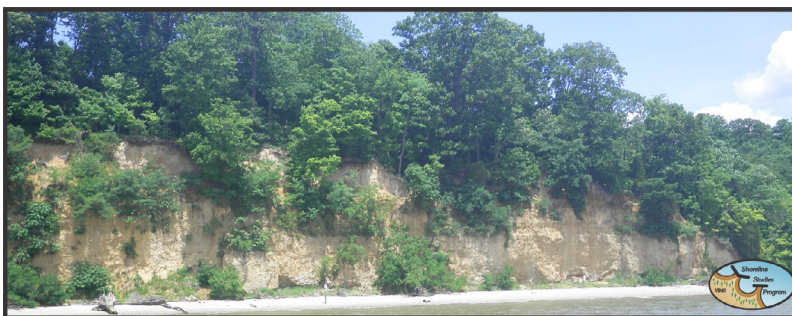
Figure 2-16. Reach 4 high eroding banks along Carters Grove Plantation.

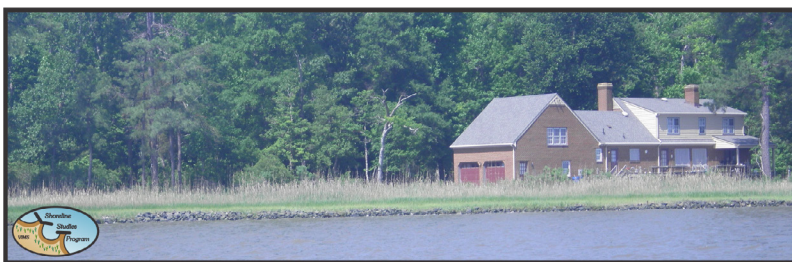
Figure 2-17. Reach 5 low marsh shoreline along the York River.

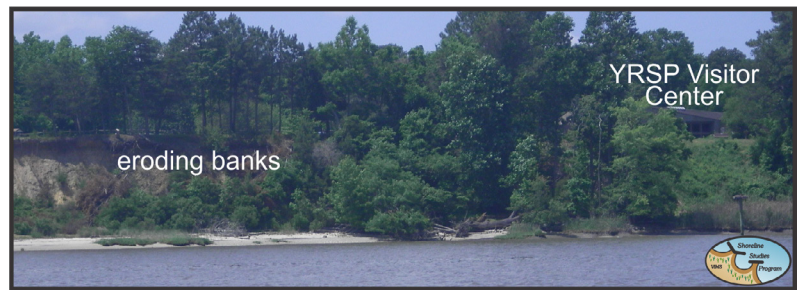
Figure 2-19. Reach 5 eroding upland banks near the Visitor Center at York River State Park.

Some remaining marshes act as low headlands that help hold a narrow beach and limit wave attack. Some of the bank strata is fossil bearing and provide a field experience to youth groups at the Park. The park's visitor center resides near the eroding river banks (Figure 2-19).

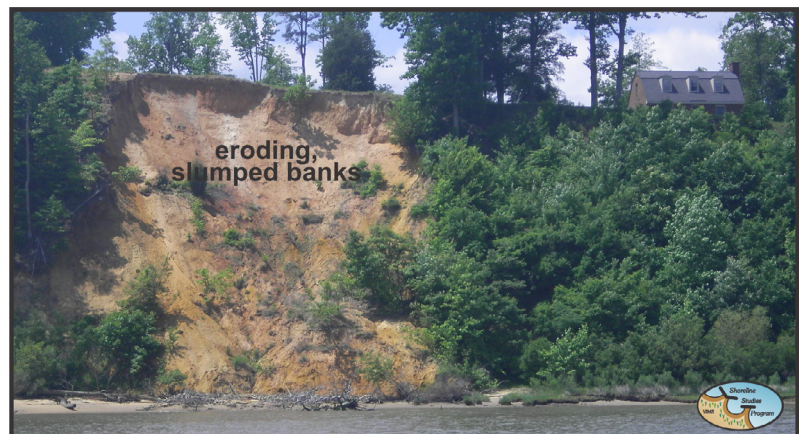
Figure 2-20. Reach 5 erosional slumped bank on the York River.

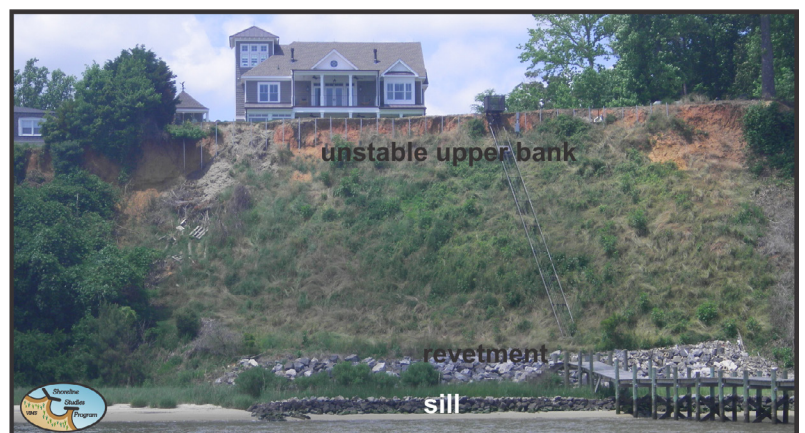
Figure 2-21. Reach 5 high bank with a sill and backshore revetment to stabilize the base of bank. The top of the bank is still unstable.

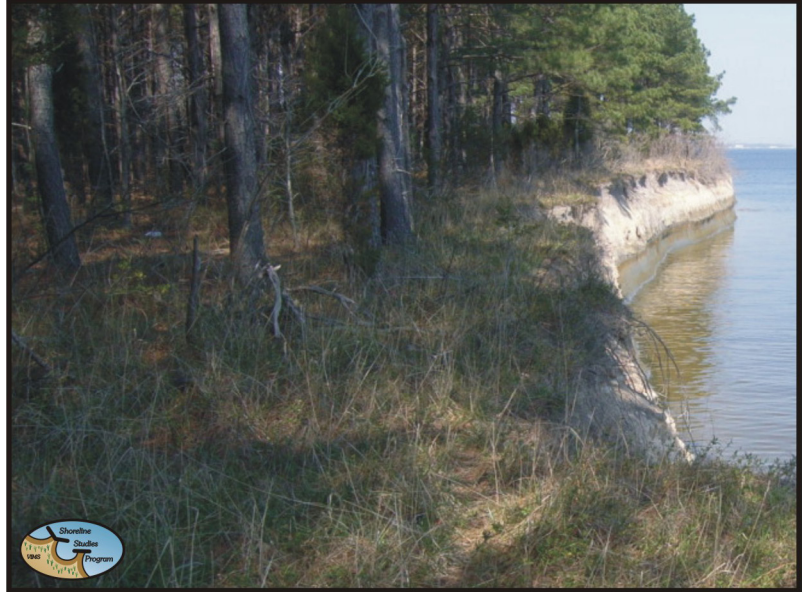
Figure 3-1. One example of forest management. The edge of the bank is kept free of tree and shrub growth to reduce bank loss from tree fall.

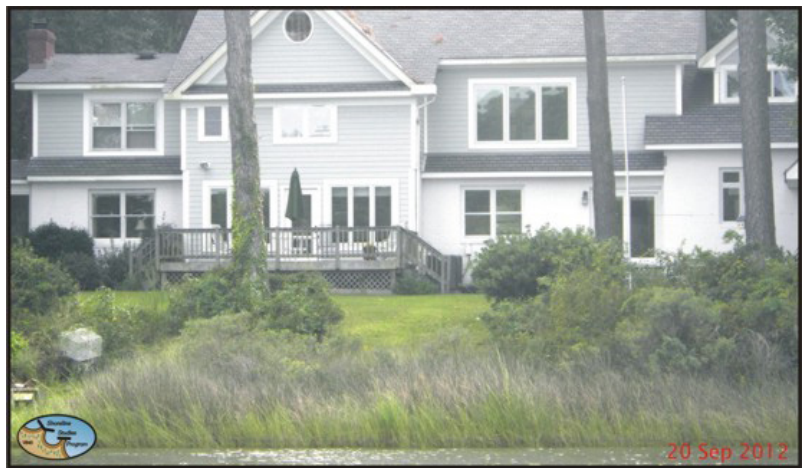
Figure 3-2. Maintaining and enhancing the riparian and marsh buffers can maintain a stable coastal slope.

Enhancement of both riparian and existing marsh buffers together can be an effective practice to stabilize the coastal slope (Figure 3-2) from the intertidal area to the upland by allowing plants to occupy suitable elevations in dynamic fashion to respond to seasonal fluctuations, shifts in precipitation or gradual storm recovery. At the upland end of the slope, forest buffer restoration and the planting of ornamental grasses, native shrubs and small trees is recommended. Enhancement of the marsh could include marsh plantings, the use of sand fill necessary to plant marsh vegetation, and/or the need for fiber logs to stabilize the bank toe and newly established marsh vegetation.

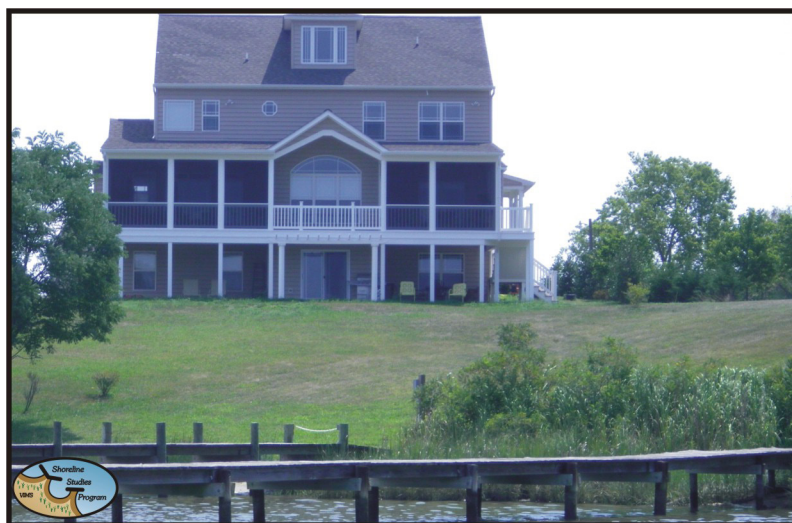
Figure 3-3. Bank grading reduces steepness and will improve growing conditions for vegetation stabilization.

In cases where the bank is unstable, medium or high in elevation, and very steep, bank grading may be necessary to reduce the steepness of bank slopes for wave run-up and to improve growing conditions for vegetation stabilization (Figure 3-3). The ability to grade a bank may be limited by upland structures, existing defense structures, adjacent property conditions, and/or dense vegetation providing desirable ecosystem services.

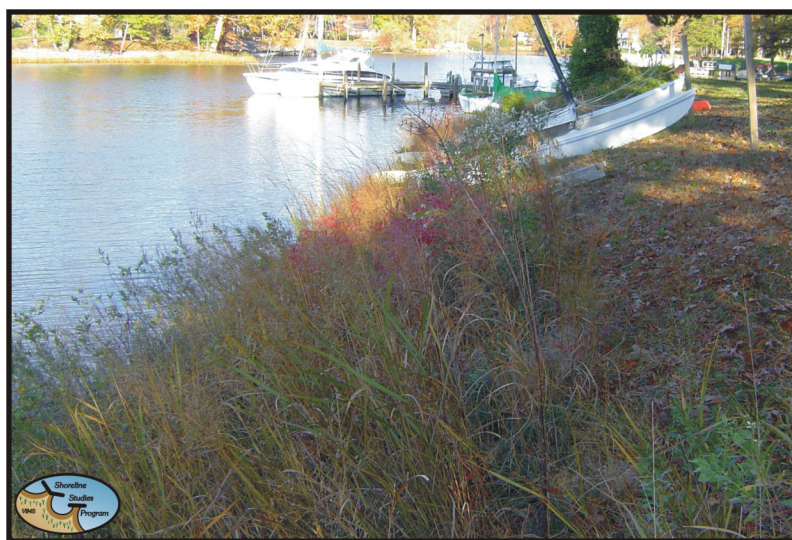
Figure 3-4. This low-energy site had minor bank grading, sand added, and *Spartina alterniflora* planted. This photo shows the site after 24 years.

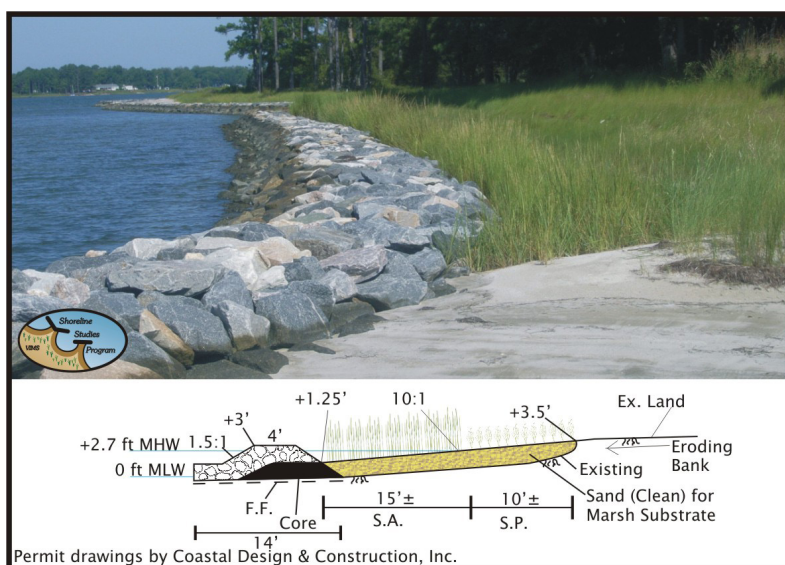
Figure 3-5. Sand fill with stone sills and marsh plantings shown six years after installation and the cross-section used for construction (From Hardaway et al., 2010).

The stone sill has been used extensively in the Chesapeake Bay over the years (Figure 3-5). It is a rock structure placed parallel to the shore so that a marsh can be planted behind it. The cross-section in Figure 3-5 shows the sand for the wetlands substrate on a slope approximating 10:1 from the base of the bank to the back of the sill. The elevation of the intersection of the fill at the bank and tide range will determine, in part, the dimensions of the sill system. If the nearshore depth at the location of a sill is greater than two feet, it might be too expensive for a sill relative to a revetment at that location. Nevertheless, the preferred approach would still be the marsh sill.

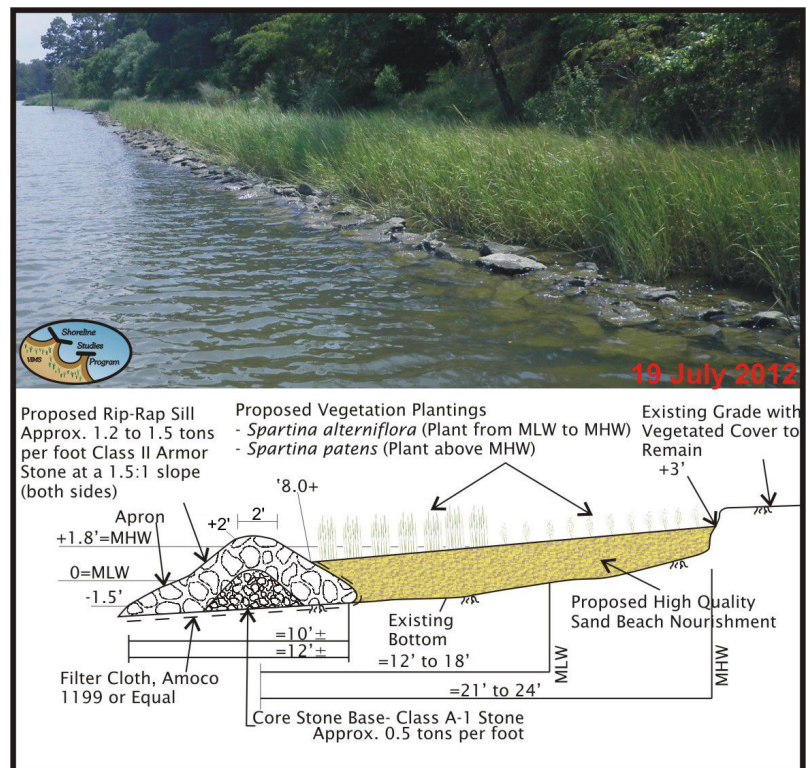
Figure 3-6. Longwood University's Hull Springs Farm four years after construction and the cross-section used for construction (from Hardaway et al., 2010).

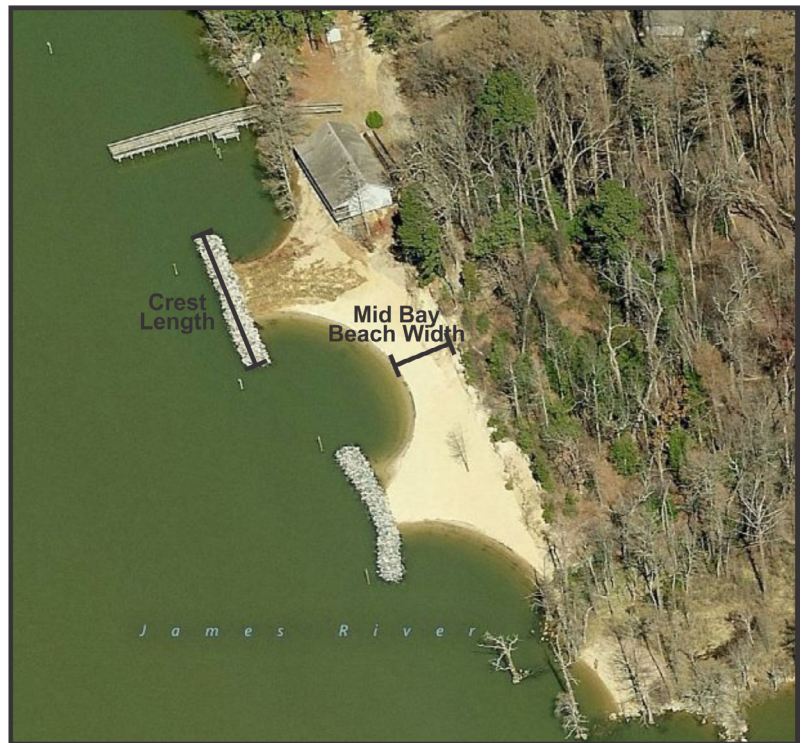
Figure 3-7. Breakwaters at the 4H camp designed to provide a recreational beach as well as storm erosion protection for the camp.

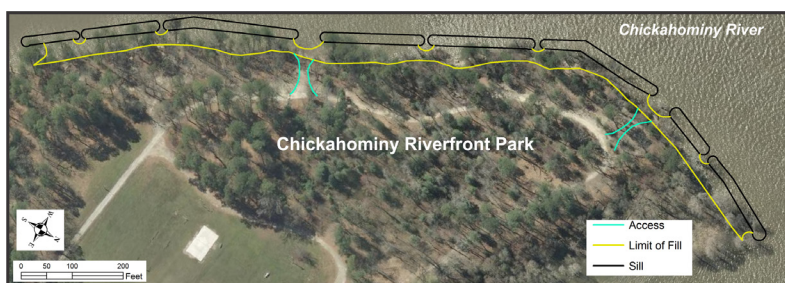
Figure 5-4. Proposed configuration of Shoreline BMP at Chickahominy Riverfront Park.

The SMM recommends a BMP of a marsh with sill along this shoreline. A conceptual design of a shore protection system which would manage the shoreline includes eight sills along about 1,600 feet of shoreline (Figure 5-4). The gapped sills would allow fauna to utilize the marshes and provides access for recreation. The cross-section for a typical sill for this site is shown in Appendix 3, Figure 1.

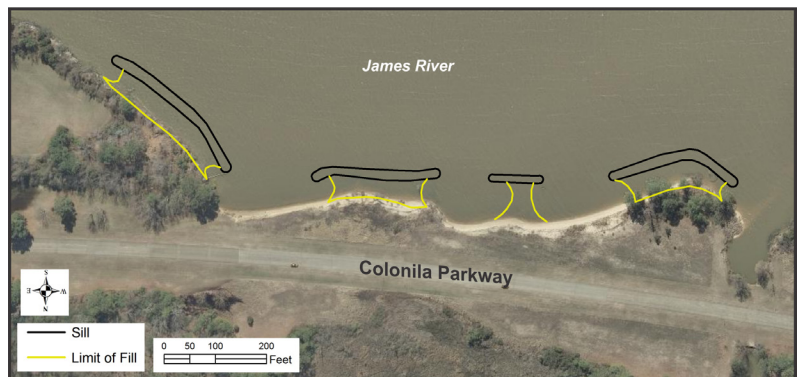
Figure 5-6. Proposed configuration of the sill shoreline BMP for Colonial Parkway.

The SMM recommends a sill with marsh along sections of this shoreline. A conceptual design includes four sill structures strategically placed along the existing headlands (Figure 5-6). These structures are designed for the medium to high wave climate that can reach this stretch of shoreline. They will reduce the erosion so that the road is not threatened in the future as well as provide recreational access. The cross-section for a typical sill for this site is shown in Appendix 3, Figure 2.

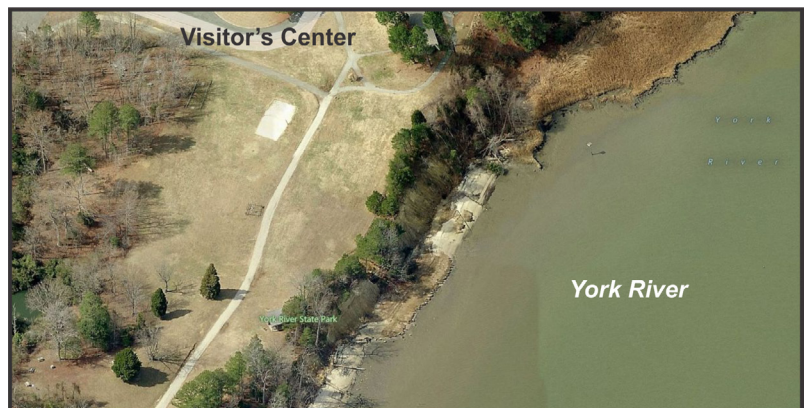
Figure 5-7. Existing conditions at the site of the York River State Park area of interest.

The shoreline along the York River State Park on the York River has a long-term (1937-2009) erosion rate up to -2.5 feet per year in some areas. The high banks are eroding leaving fallen trees and scarped banks along the shoreline (Figure 5-7). This is a high energy area that has a fetch to the northwest of 7.5 miles and southeast of 15.5 miles.

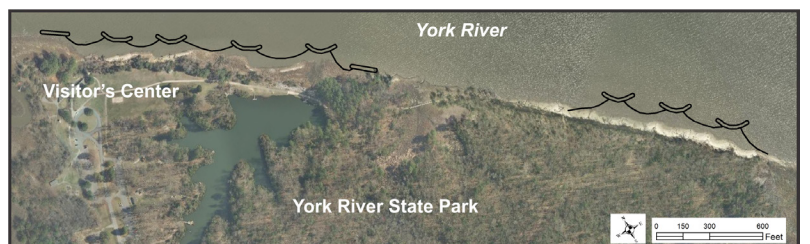
Figure 5-8. Proposed configuration of Shoreline BMP for York River State Park.

The SMM recommends offshore breakwaters which will provide shore protection and recreational access to the shoreline. Conceptual designs are provided for two separate areas along the York River State Park shoreline (Figure 5-8). These are in line with earlier designs created by the U.S. Army Corps of Engineers. In the first area near the Visitor's Center, four offshore breakwaters and two transitional sills are recommended which will provide beach and marsh habitat, respectively. The structures farther downriver are in front of high eroding banks. These three offshore breakwaters will stabilize the base of bank from severe storm attack. Bank grading is optional. The cross-section for a typical sill for this site is shown in Appendix 3, Figure 3.

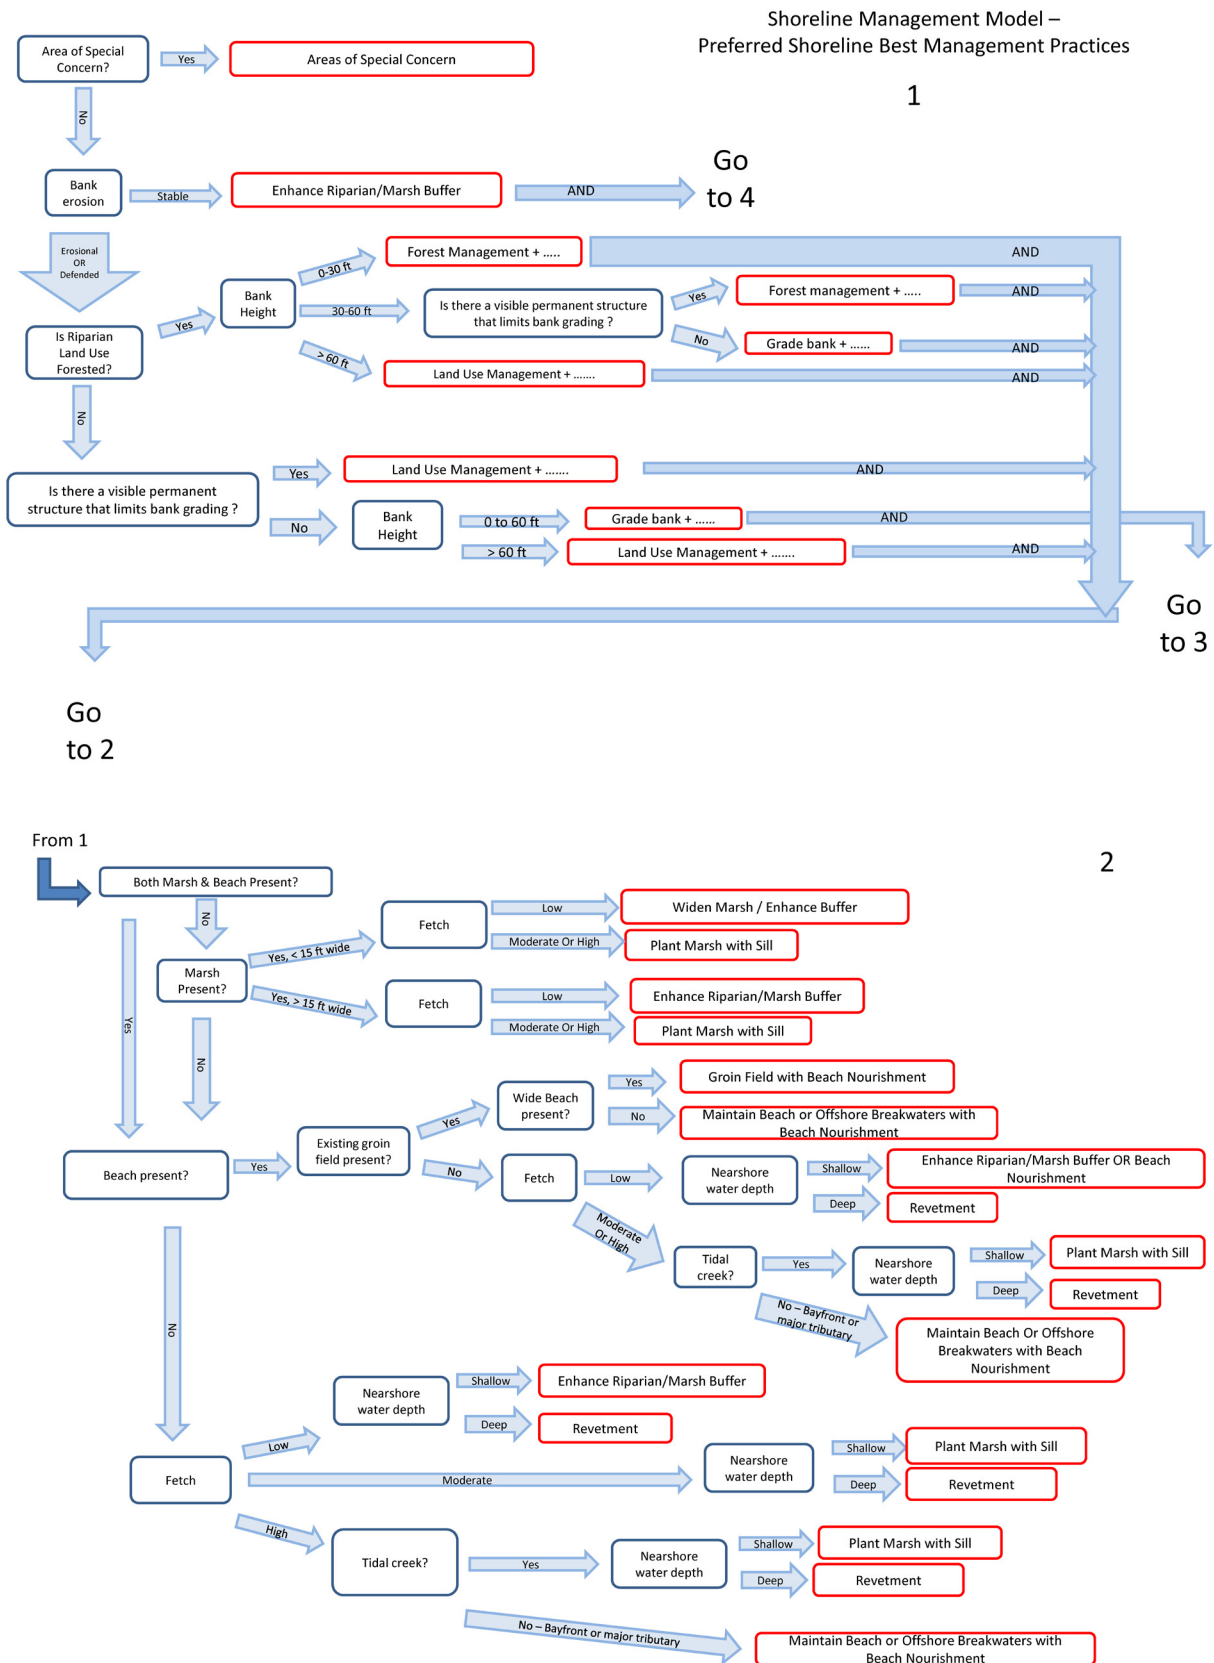
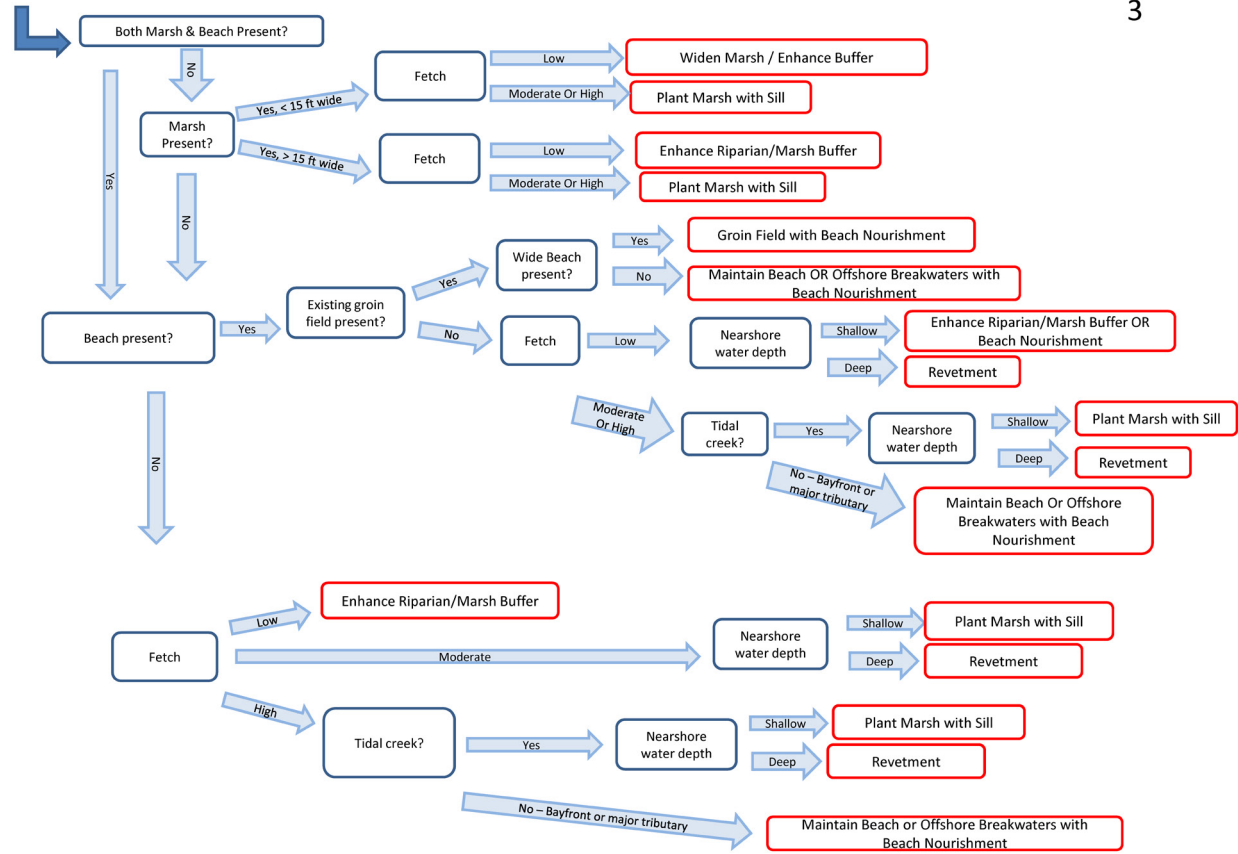
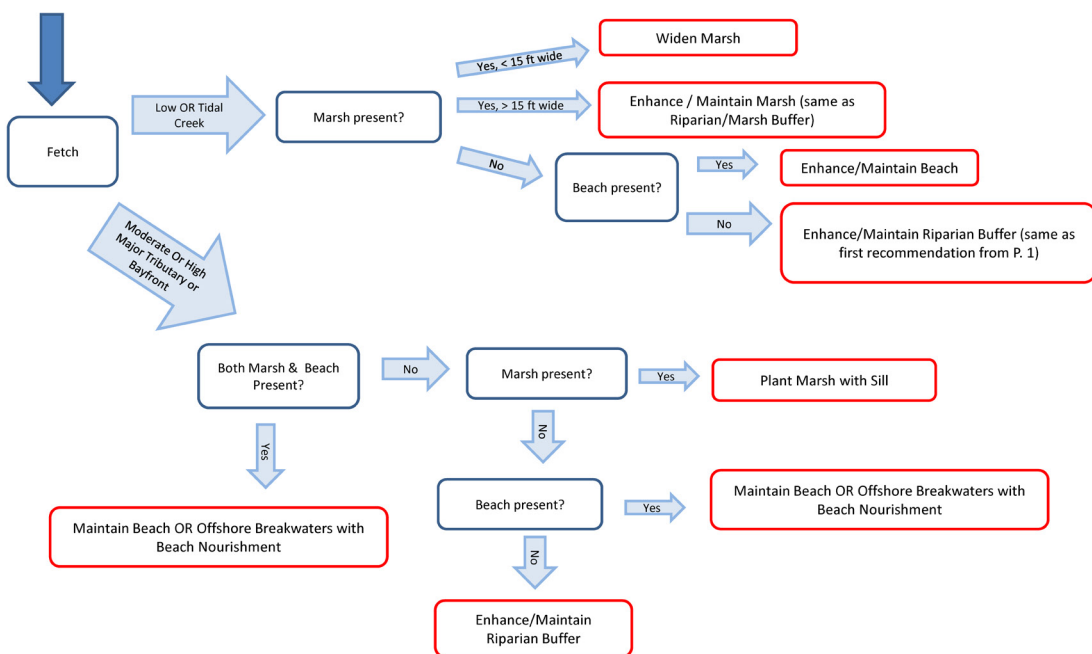
Shoreline Management Model Flow Diagram

The model is constructed using multiple decision-tree pathways that lead the user to a final recommended strategy or strategies in some cases. There are four major pathways levels. The pathways are determined based on responses to questions that determine onsite conditions. Along the upland and the bank, the model queries a site for bank stability, bank height, presence of existing infrastructure, land use, and whether the bank is defended to arrive at an upland management strategy. At the shore the model queries a site for presence and condition of beaches, marshes, the fetch, nearshore water depth, presence of specific types of erosion control structures, and creek setting to drive the shore recommendations. Appendix 1 illustrates the logic model structure.

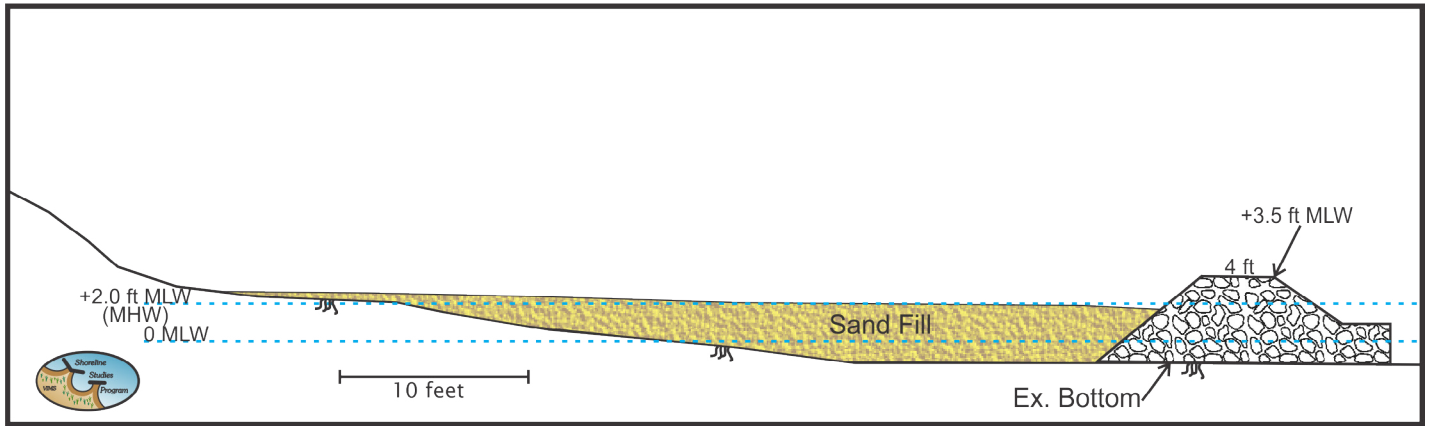
Figure 2. Typical cross-section for a large sill that is appropriate for the medium to high energy shorelines of James City County. The project utilizes clean sand, and the bank can be graded to a (minimum) 2:1 slope, if appropriate.

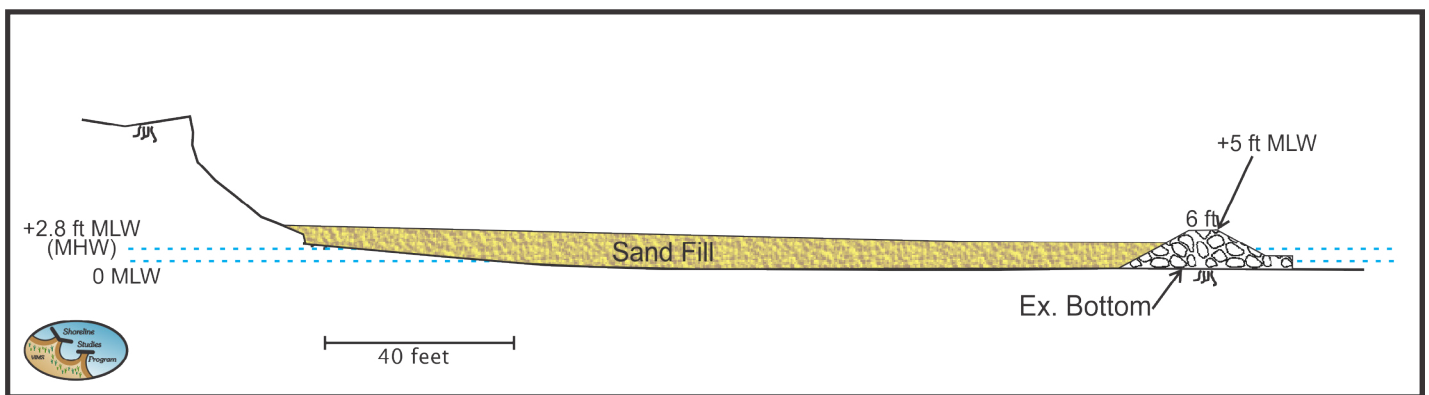
Figure 3. Typical cross-section for a breakwater that is appropriate for shore protection along the medium to high energy shorelines of James City County. The project utilizes clean sand, and the bank can be graded to a (minimum) 2:1 slope, if appropriate.
